## Case Study

### STEEL STRUCTURAL PLATE RELINE

## Pennsylvania Stone Arch Bridge Rehabilitation Eleventh Street Bridge at Macoby Creek Montgomery County, PA

#### Eleventh Street Bridge

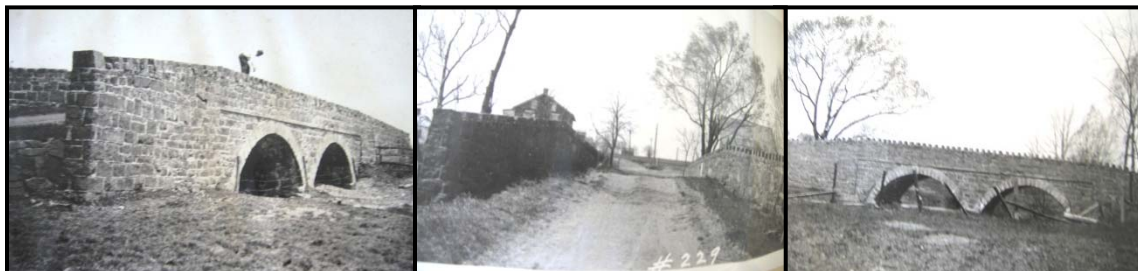
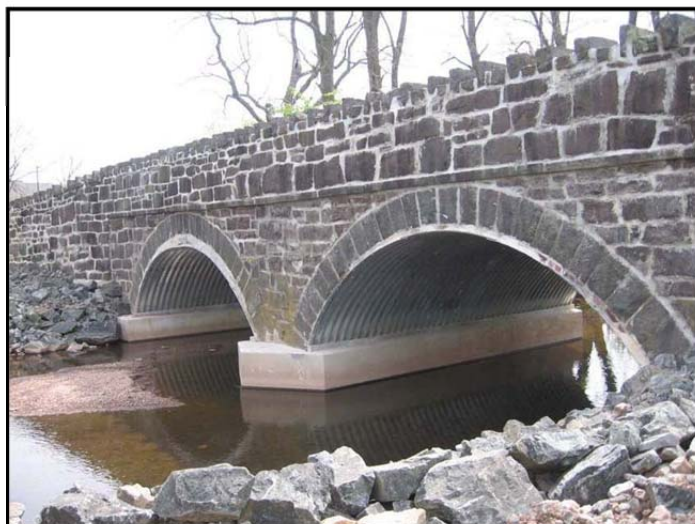
Earliest photos of record taken during a 1916 inspection of the Eleventh Street Bridge (photos courtesy of Montgomery County Department of Roads and Bridges).

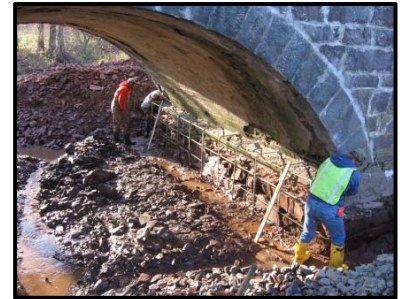
As evidenced in the photo at right, increased deterioration of the concrete arch threatened the overall stability of the structure. An existing diagonal crack along the apex was noticeably widening with each successive inspection, and the footing was no longer providing scour protection.

Rehabilitation work started in October 2009. Due to an uncooperative winter the project was not completed until May 2010. The first order of business involved the reconstruction of the arch footings, which had eroded over time and was progressively undermining foundation material.
