Case Study

SPIRAL RIB RELINE PIPE

Rehabilitation of RIDOT Greenville Bridge No. 99 Slip-Lining to Stabilize Stone Masonry Culvert Smithfield, Rhode Island

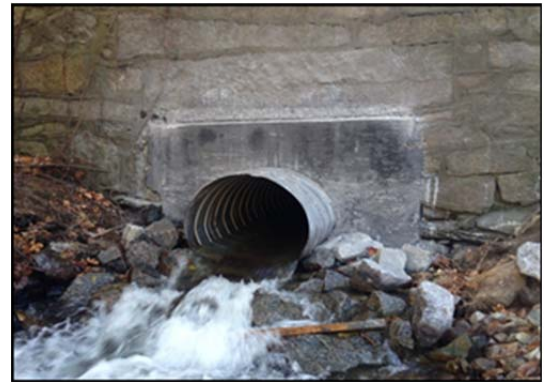
Outfall of the newly relined stone masonry culvert completed as part of the reconstruction of Route 44 in Smithfield, Rhode Island near Smith Avenue (Route 116).

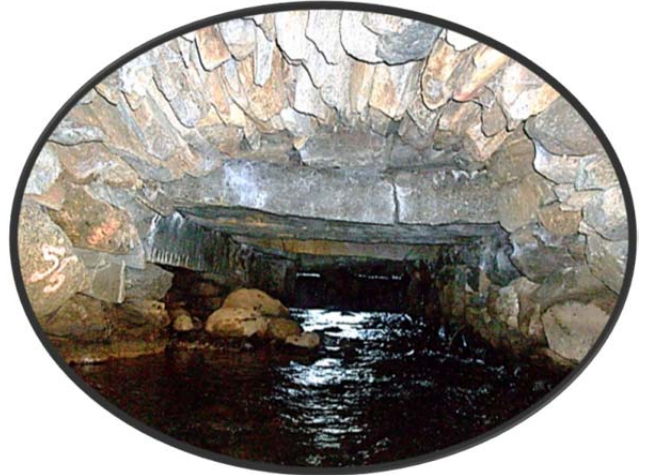
Modifications to the existing channel were needed to accommodate the slip-lining process, primarily the creation of additional vertical clearance in an area. Preparatory work included obstruction removal, void blocking/filling, and streambed re-grading. The photo at right illustrates the variable nature of the channel cross-section and the challenges presented both in design and construction.

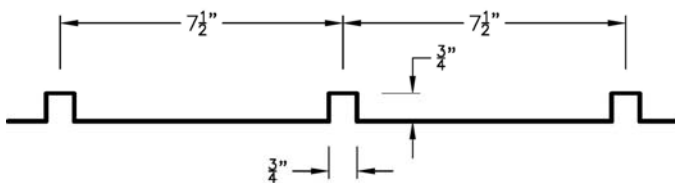
Figure 1. Spiral Rib Pipe Profile

The spiral rib profile is a corrugation with outwardly projected rectangular ribs and a smooth interior with a Manning's roughness coefficient of 0.012, primarily developed for storm sewer applications, but ideal as a reline material due to the narrow wall profile and smooth interior (see Figure 1 opposite page). With the ability to manufacture corrugated steel pipe in custom sizes, the spiral rib reline pipe was arched to the specified dimensions, matching the hydraulic capacity of the existing structure with a slight increase in grade, and thereby eliminating any additional bureaucracy associated with changing the impact upstream or downstream of the culvert.
