Case Study: Eleventh Street Bridge at Macoby Creek Pennsylvania Stone Arch Bridge Rehabilitation

Restoration of Montgomery County Bridge No. 229 preserves one of The Greater Philadelphia Region's historic stone arch bridges. The Montgomery County Department of Roads and Bridges project features corrugated steel structural plate reline with new footers as the mode of renewed structural capacity.

Eleventh Street Bridge

Two-barrel stone masonry arch bridge originally constructed in 1906 (County Bridge No. 229)

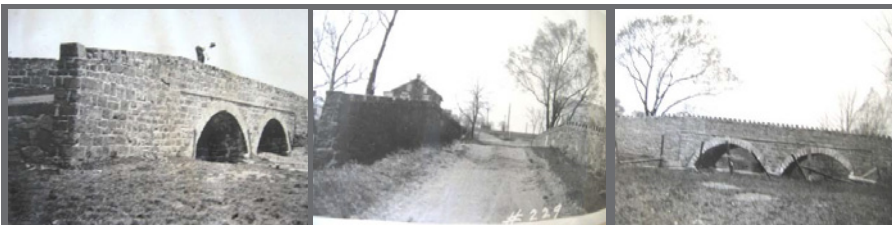
Earliest photos of record taken during a 1916 inspection of the Eleventh Street Bridge (photos courtesy of Montgomery County Department of Roads and Bridges).

As evidenced in the photo at right, increased deterioration of the concrete arch threatened the overall stability of the structure. An existing diagonal crack along the apex was noticeably widening with each successive inspection, and the footing was no longer providing scour protection.

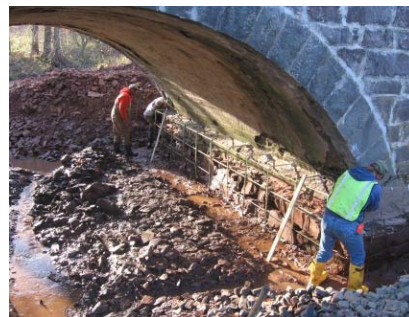
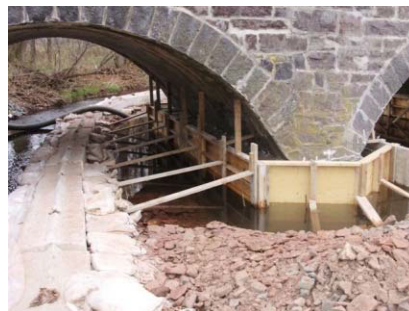
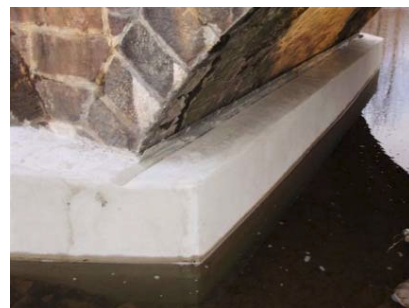
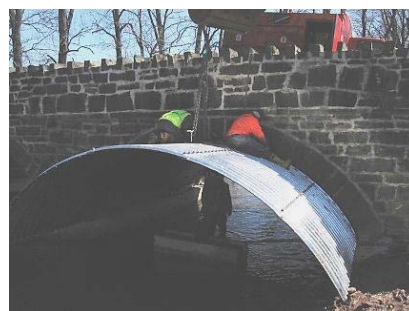
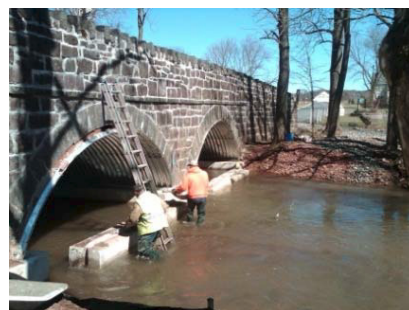
Water being diverted from the work area allowed foundation rehabilitation to commence. Having sufficiently removed any loose material, workers began constructing the rebar cage around the main pier, followed by formwork and concrete pours. The procedure was followed in kind for the remaining piers.

The footings were constructed with an unbalanced channel cast into the top of the footer at the base of the arch. The unbalanced channel is a typical component for a plate arch, providing a groove for the plate edge to be positioned and ultimately fastened.

With the footers completed, the plate relining operation was ready to begin. Structural plate is shipped to the site in curved plates and field assembled into its final shape by bolting. Although plate assembly for relining jobs can take place within the structure itself, the project management team recognized the ease of first assembling the plate arch and then sliding the completed structure into position along the unbalanced channels. Some minor field modifications were made to the plate to accommodate a slight skew in one of the concrete arches, but overall the plate arch insertion went well.

The remaining task in the relining work consisted of constructing a bulkhead around the arch periphery so that the annular space between the plate and concrete could be pressure grouted. The structural plate included grout ports to facilitate the operation. Including grout ports at strategic locations around the arch periphery throughout its length ensures the grout to be evenly distributed throughout the annular space. Although structural plate is designed as a standalone product with appropriately compacted granular backfill, the composite interaction developed with the remaining portions of the concrete arch makes future capacity issues a moot point. To further solidify composite action with the entire structure a reinforced concrete slab was constructed over the arches to better distribute vehicle loads and tie the fascia walls into the new deck.
