## Case Study

### STEEL STRUCTURAL PLATE RELINE

## Pennsylvania Stone Arch Bridge Rehabilitation Eleventh Street Bridge at Macoby Creek Montgomery County, PA

#### Eleventh Street Bridge

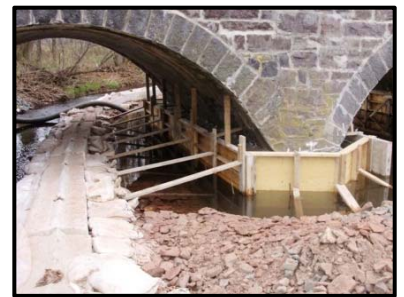
As evidenced in the photo at right, increased deterioration of the concrete arch threatened the overall stability of the structure. An existing diagonal crack along the apex was noticeably widening with each successive inspection, and the footing was no longer providing scour protection.
