Case Study

SPIRAL RIB RELINE PIPE

Rehabilitation of RIDOT Greenville Bridge No. 99 Slip-Lining to Stabilize Stone Masonry Culvert Smithfield, Rhode Island

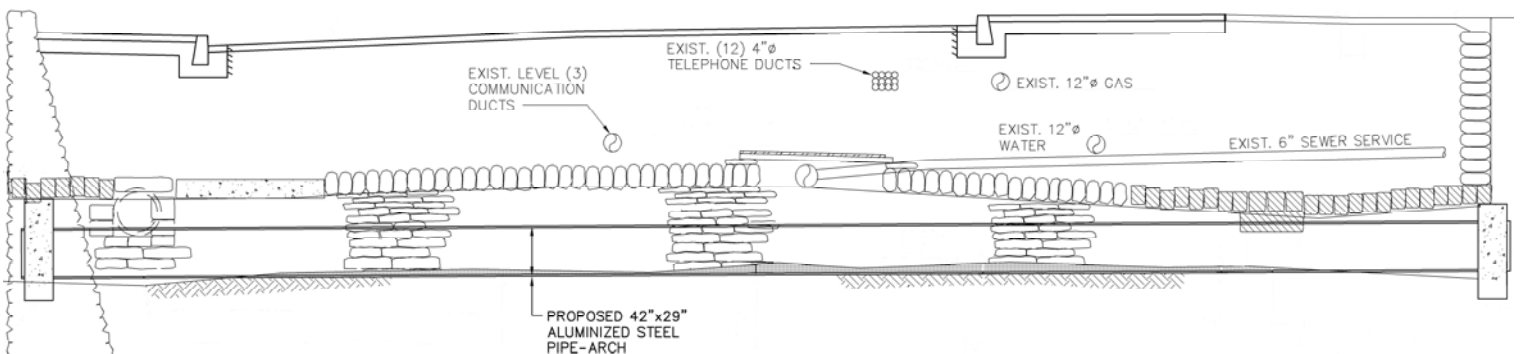
Before - Stone Masonry Culvert
5' span, 3' rise (assumed avg.)
Manning's roughness, $n = 0.04$
Slope at 0.5% (assumed avg.)
Hydraulic capacity ~ 55.14 cfs

After - Spiral Rib Pipe-Arch
42" span, 29" rise
Manning's roughness, $n = 0.012$
Slope at 0.61%
Hydraulic capacity ~ 55.20 cfs
