Case Study: Connecticut DOT, Naugatuck, CT Waterbury Branch Railroad Culvert Relining

CTDOT
Project No. 300-102
Bridge No. 08280R
Waterbury Branch

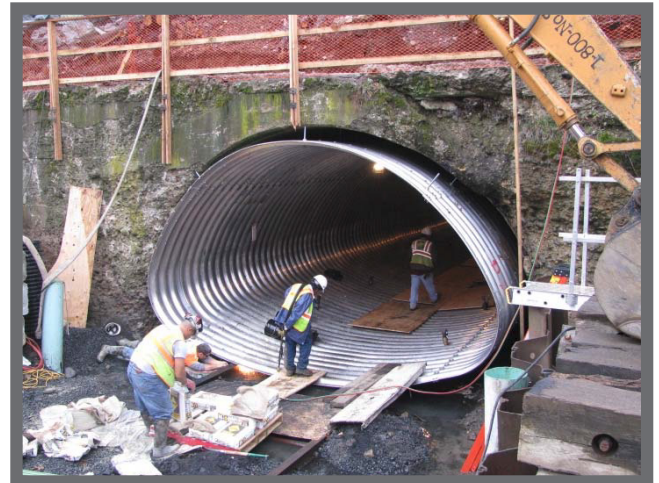
The existing concrete arches each had a 20' span and an open (i.e. natural) bottom. An 18'-5" x 11'-6" aluminum structural plate pipe arch shape was chosen for the reline material. The south culvert required 109' of relining, while the north culvert required 111'.

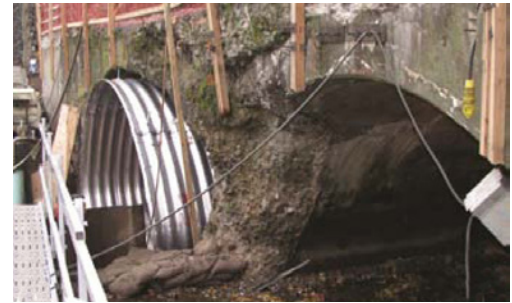
With flow bypassed into the north culvert and a cofferdam constructed around the south culvert outfall, the south culvert was completely lined with structural plate in one day. A reversal of this arrangement facilitated the installation of the north culvert in a similar fashion.

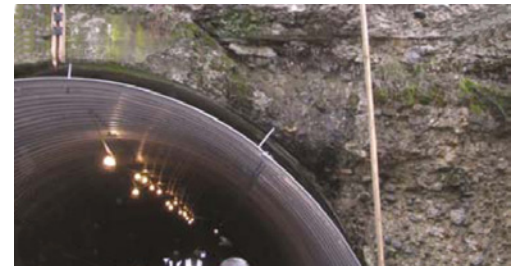
Once the structural plate is assembled and the bolts are tightened, the pipe arch is precisely positioned with the use of alignment bolts. Alignment bolts around the periphery and along the entire length of the relining plate ensure the shape is properly situated within the host structure.

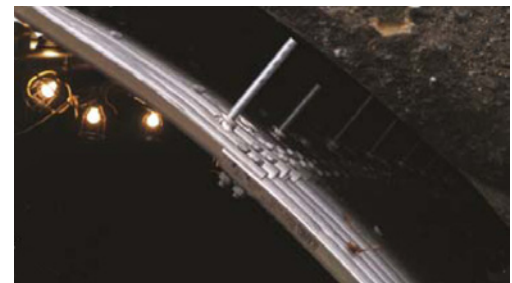
After the pipe arch has been completely aligned into its final position, preparations can be made to grout the annular space. The relining plate includes a number of grout plugs around the circumference and along the length to facilitate this process.

Due to the buoyant forces generated as the annular space is filled, additional bracing may be necessary to help counteract any associated movement. The grouting is typically staged into multiple lifts to lesson any flotation effects, with adequate setting time allowed between each pour.

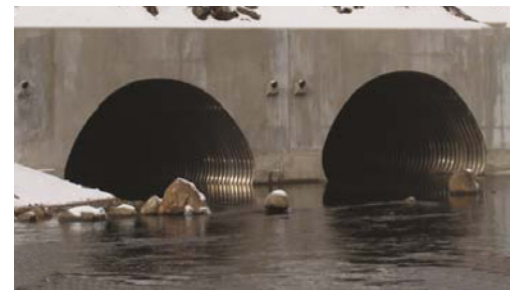
The project included the complete rehabilitation of the concrete headwall. This final touch brought the appearance of the culvert restoration to a “like new” condition. From beginning to end the restoration project was accomplished in two months.
