Case Study

STEEL STRUCTURAL PLATE RELINE

Maintaining Tunnel Co-Habitants Mid State Trail Poe Paddy Tunnel Reline Bald Eagle State Forest, Central PA

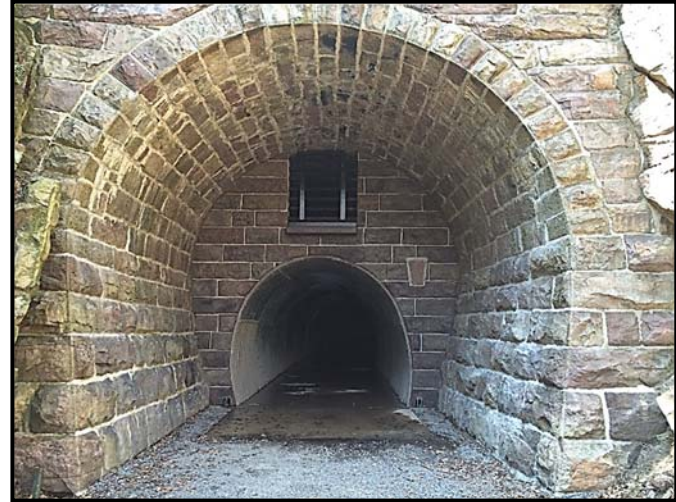
Steel Structural Plate Reline 307-ft Curvilinear Alignment 11'-9" x 9'-11" Arch 10 Horizontal Elbows

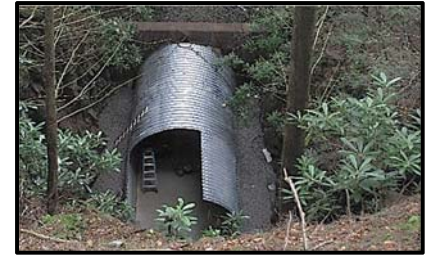
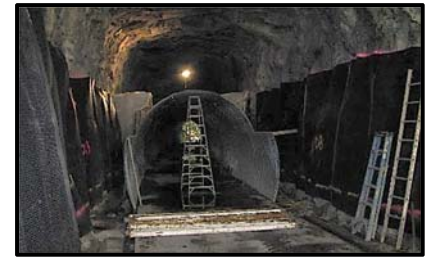
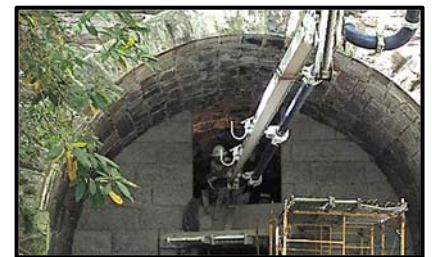
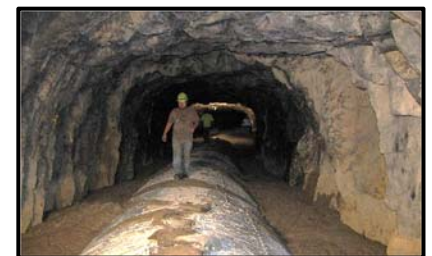
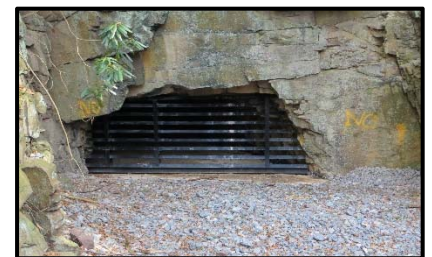
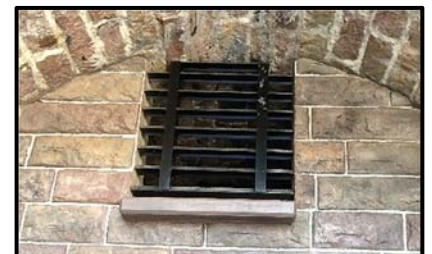
The window for construction activities was limited to the period when the bats vacated the tunnel for the year, contractually defined between May 1 and October 1, 2015. To provide additional safety from falling rocks, installation of the plate liner was designed to begin outside the north end of the tunnel roughly 50 feet from the existing rock sheared opening where a new headwall was constructed. This portion of the tunnel was backfilled with crushed stone to an elevation that preserved a small natural opening in the rock face where the smaller of the two bat friendly gates was installed (photo second from bottom).

The curved plates were assembled and bolted in place to form the 11'-9" x 9'-11" arch. The 307-ft curvilinear alignment needed ten course corrections to maintain the tunnel curvature from one end to the other, easily accommodated through specially fabricated elbow-type fittings provided by the manufacturer.

To accommodate the bats, the design included the preservation of 5 to 7 feet of space below the tunnel ceiling for a hibernation cave. Concrete was pumped through the opening left in the south headwall, filling the annular space between the existing tunnel and the new arch and extending in height a minimum of one foot above the arch to form a floor to the cave, with several 3 to 6 inch depressions to allow water pooling.

The renovation was complete with the installation of bat friendly gates at each end of the tunnel, designed to American Cave Conservation Association (ACCA) and Bat Conservation International standards, with access provisions included on the north gate for hibernacula survey (gate designs by Chris Sanders, Sanders Environmental). The different type and sized openings work together to regulate air flow mimicking what was naturally occurring before the renovation.
